RENESAS TECHNICAL UPDATE

Product Category	MPU/MCU		Document No.	TN-RL*-A076A/E	Rev.	1.00
Title	Notice for using RAA604S00		Information Category	Technical Notification		
Applicable Product	RAA604S00	Lot No.	Reference Document	RAA604S00 User's Manual: Hardware Rev.1.20 R01UH0567EJ0120(Nov 2016)		
		All lots

This document describes correction of errors in the RAA604S00 User's Manual: Hardware Rev.1.20 (R01UH0567EJ0120)

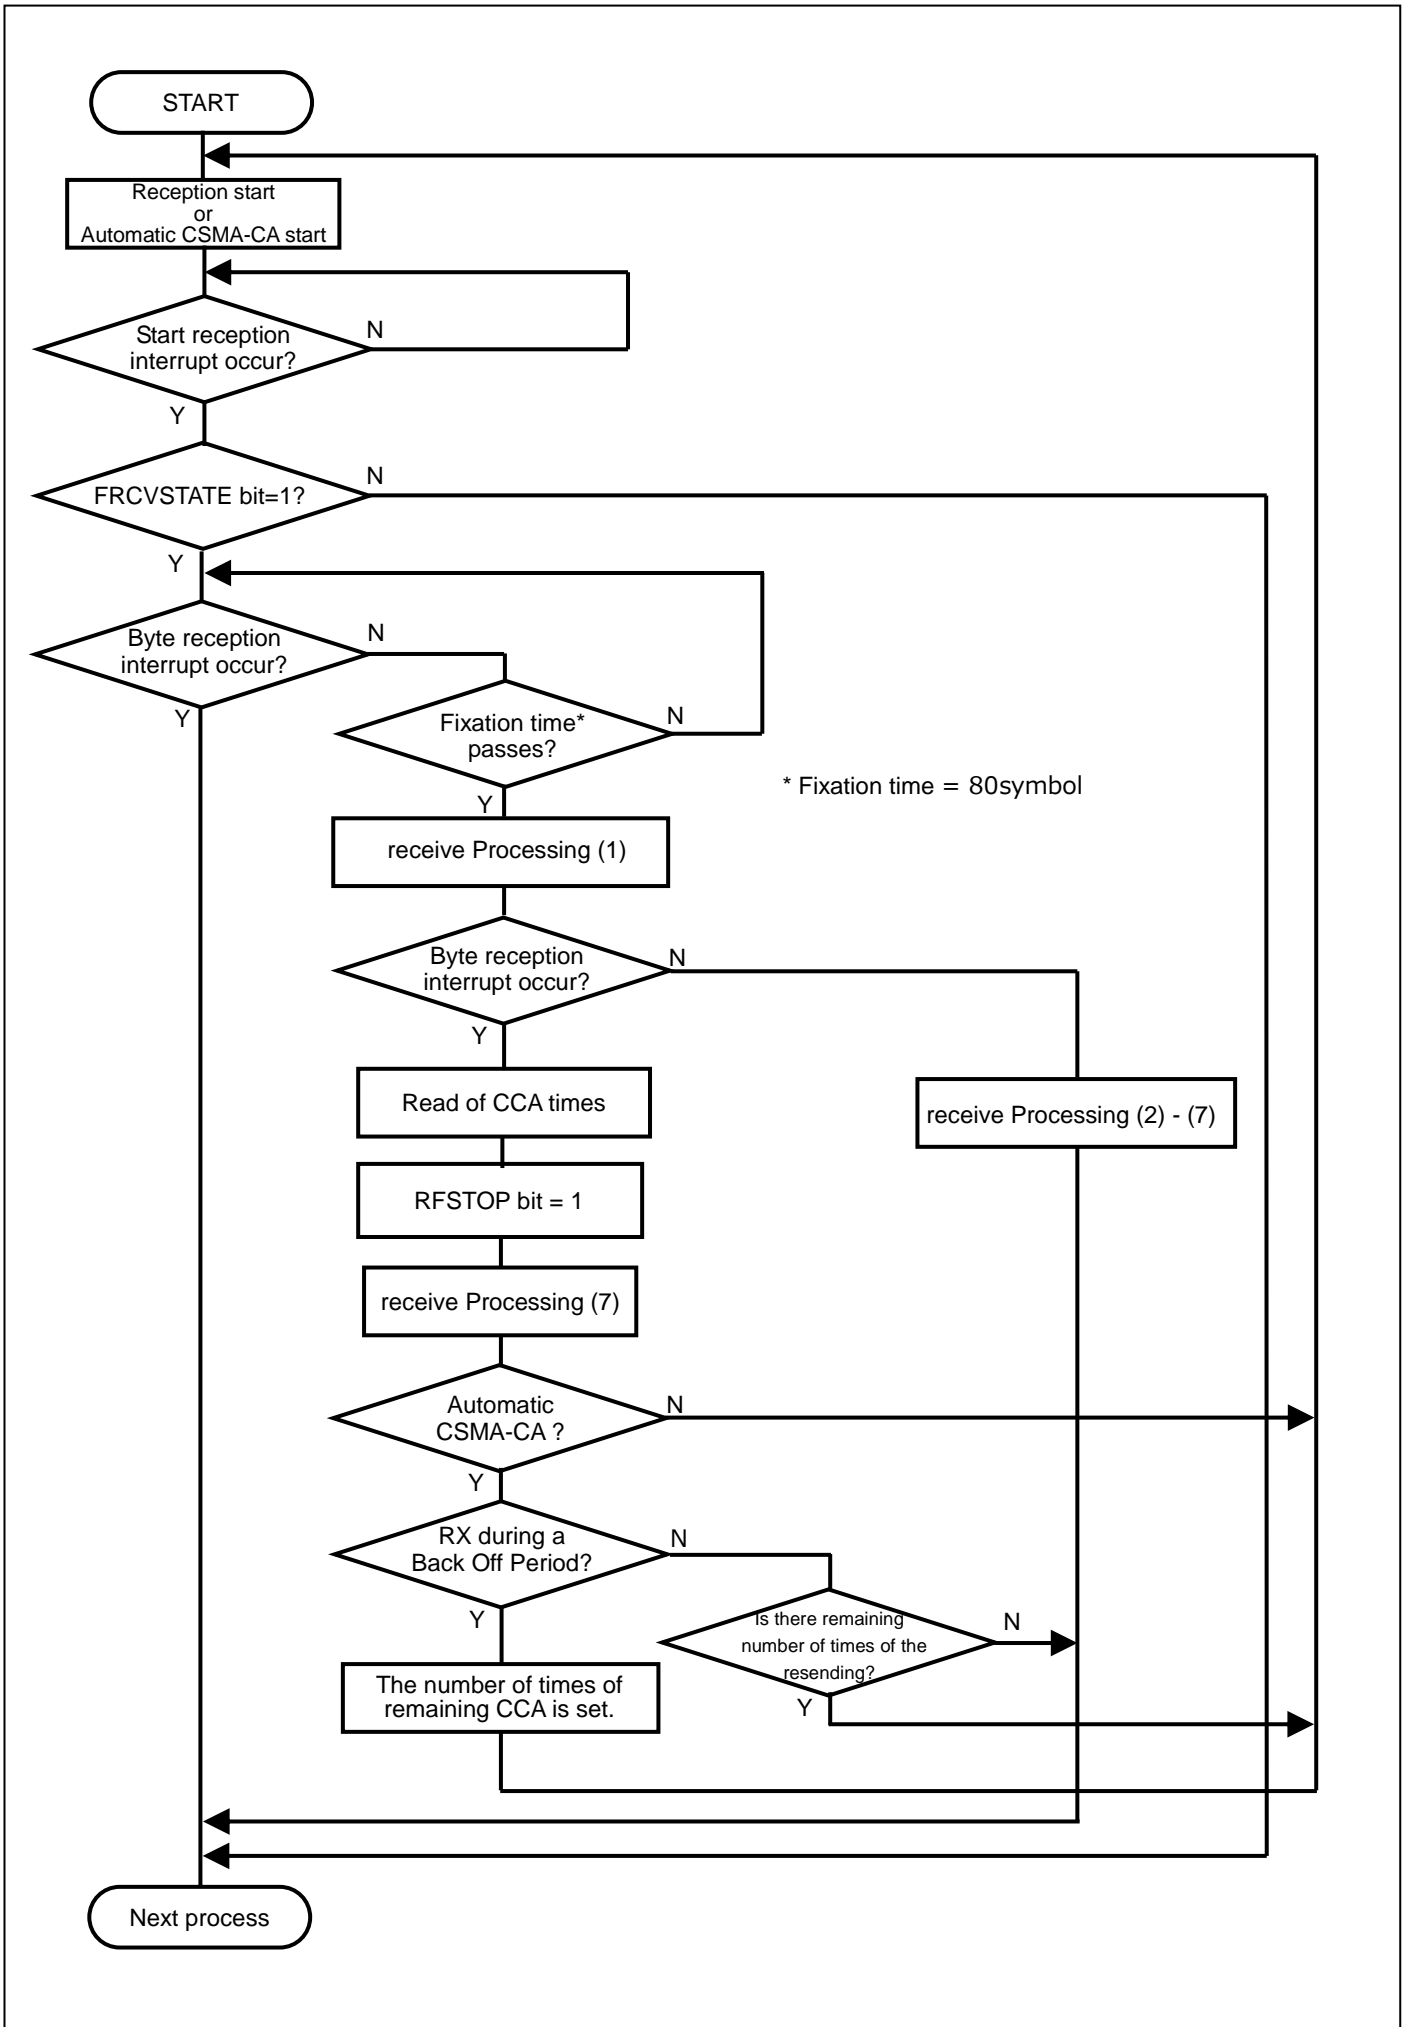
Do the following procedure, when Byte reception interrupt does not occur in the reception mode of using Start reception interrupt and Byte reception interrupt.

The procedure (2) – (6) depend on the situation.

- (1) 0077h address is set to 05h.
- (2) 0077h address is set to 06h.
- (3) 0060h address is set to 0Dh.
- (4) 0063h address is set to 00h.
- (5) 0063h address is set to 00h.
- (6) 0060h address is set to 01h.
- (7) 0077h address is set to 07h.

The details are in the flow chart on the next page.
